**Digging Deeper With Doug Ellison  
Number 3 in a Series  
The Mystery Of Signal 240.3 At Earleville, NY**

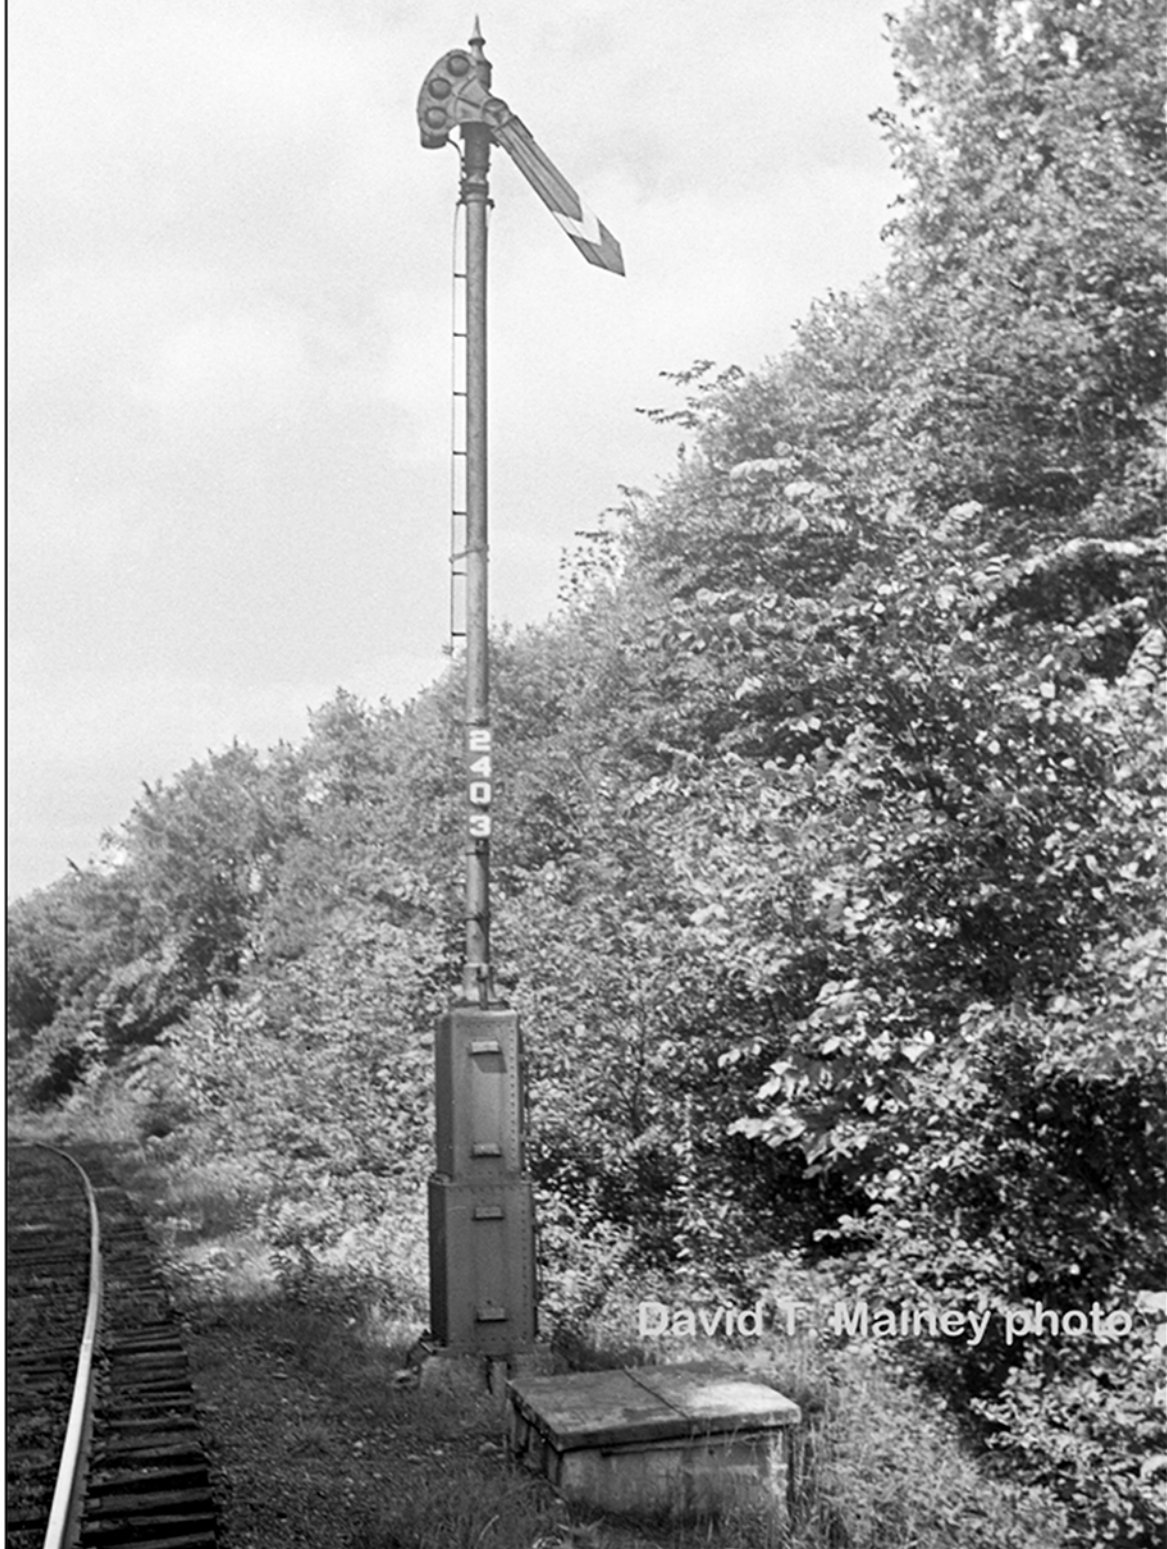
David Mainey has captured an elusive and long sought after photo of Signal 240.3. We are looking north towards the West Main Street crossing and the depot (ca. late 1940's). The depression-era hobo camp was to the immediate right, about 25 feet between the signal and the Chenango River. The Signal indicates Proceed in the position pictured.

The signal was a single-arm US&S Style-B lower-quadrant automatic semaphore with a pointed blade to control the movement of northbound trains. O&W employee timetables, supplemental instructions and rules can help us define more about its function, so let's start there.

Photographer David Mainey was visiting the area in the late 1940's and wandered trackside to take a few photos. Recently these photos came to my attention and they are shared here. It was a dream come true to find not only a photo of an O&W diesel in Earlville, the only known one so far, but a photo of the mystery signal that was so elusive for so many years. For that we thank Mr. Mainey. Obviously, he was also drawn here, and with a camera, so all of us can see what was actually here.

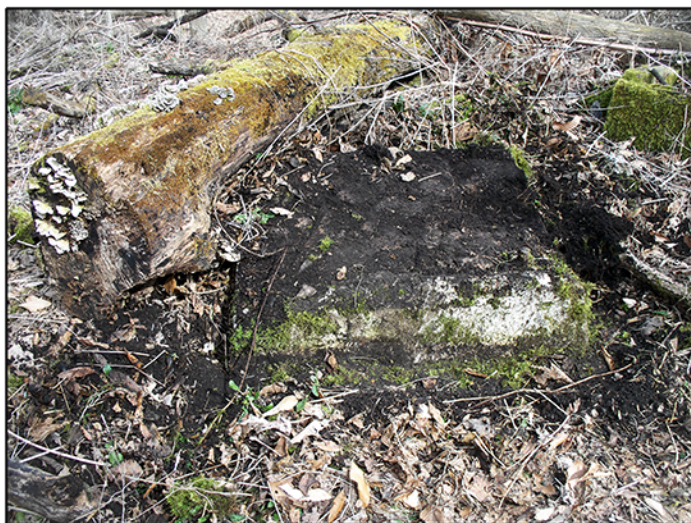
Signal Mast Foundation as it appeared on March 27, 2010 (Doug Ellison)

who also had no real answer, but the signal was active, inspected and maintained, probably until the last day of the O&W. Most likely it disappeared in the Summer of 1958 when the scrap train went through, but in any event all that was left in my day was the foundation and battery box and some cable.

Over the years since those balmy 1960's summer days, I have walked down to that magic spot many times, poked around the signal foundation and battery box and the ever diminishing remains of the hobo camp. After all these years, it is still a magnet and still a mystery as to why there was a signal here.

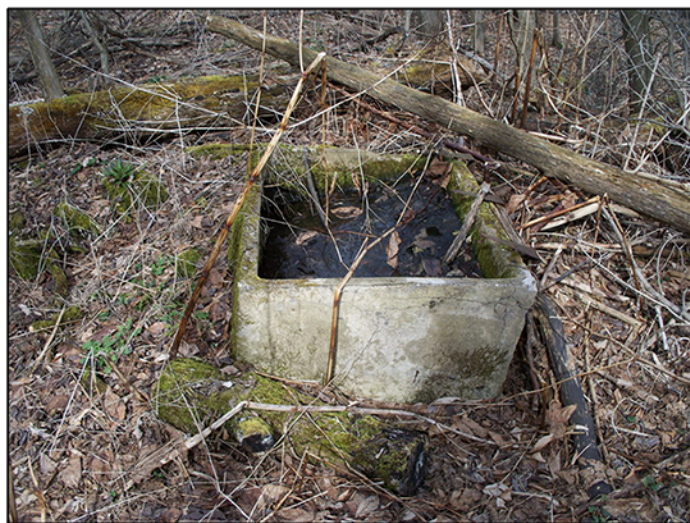
Battery Box on March 27, 2010 (Doug Ellison)

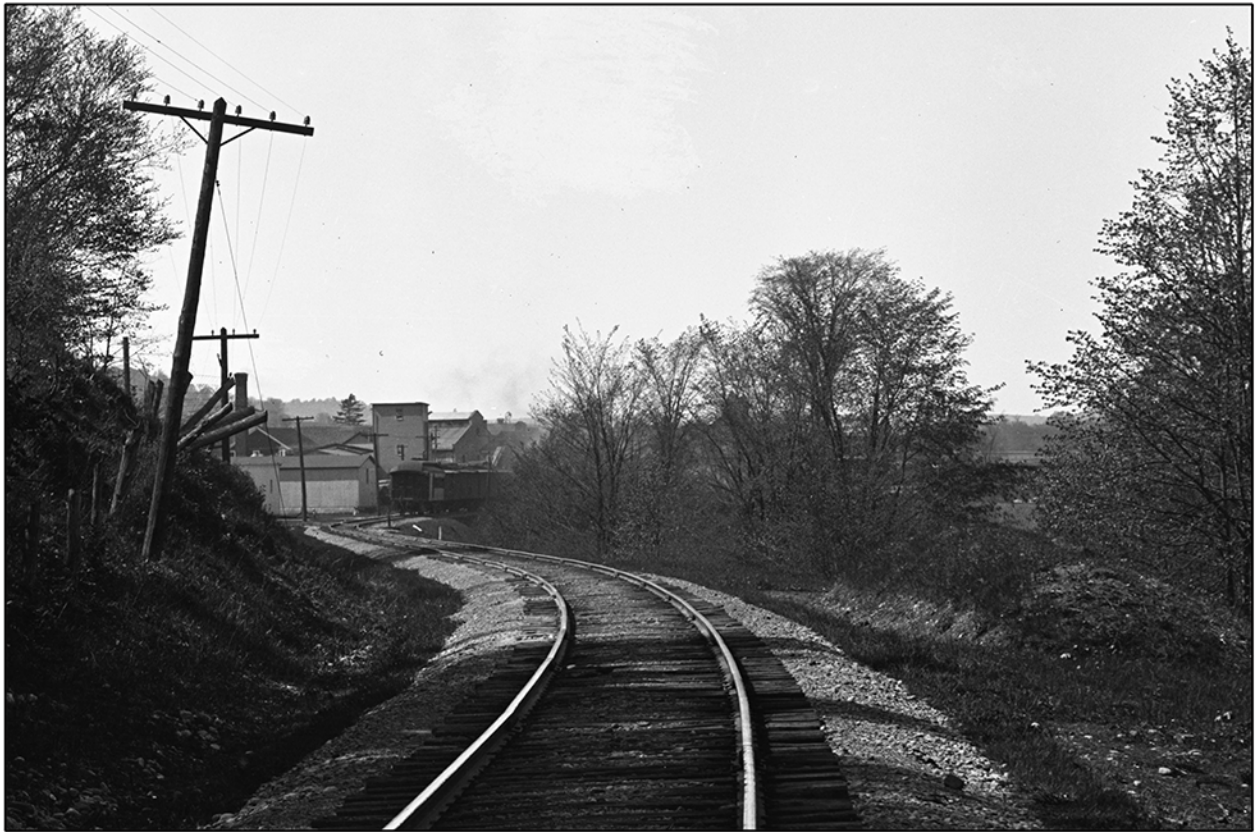
A view from near MP 240.3 looking north towards the Consumers Dairy Turnout, West Main Street Crossing and the Earlville Depot in the early 1900's (O&W Archives)

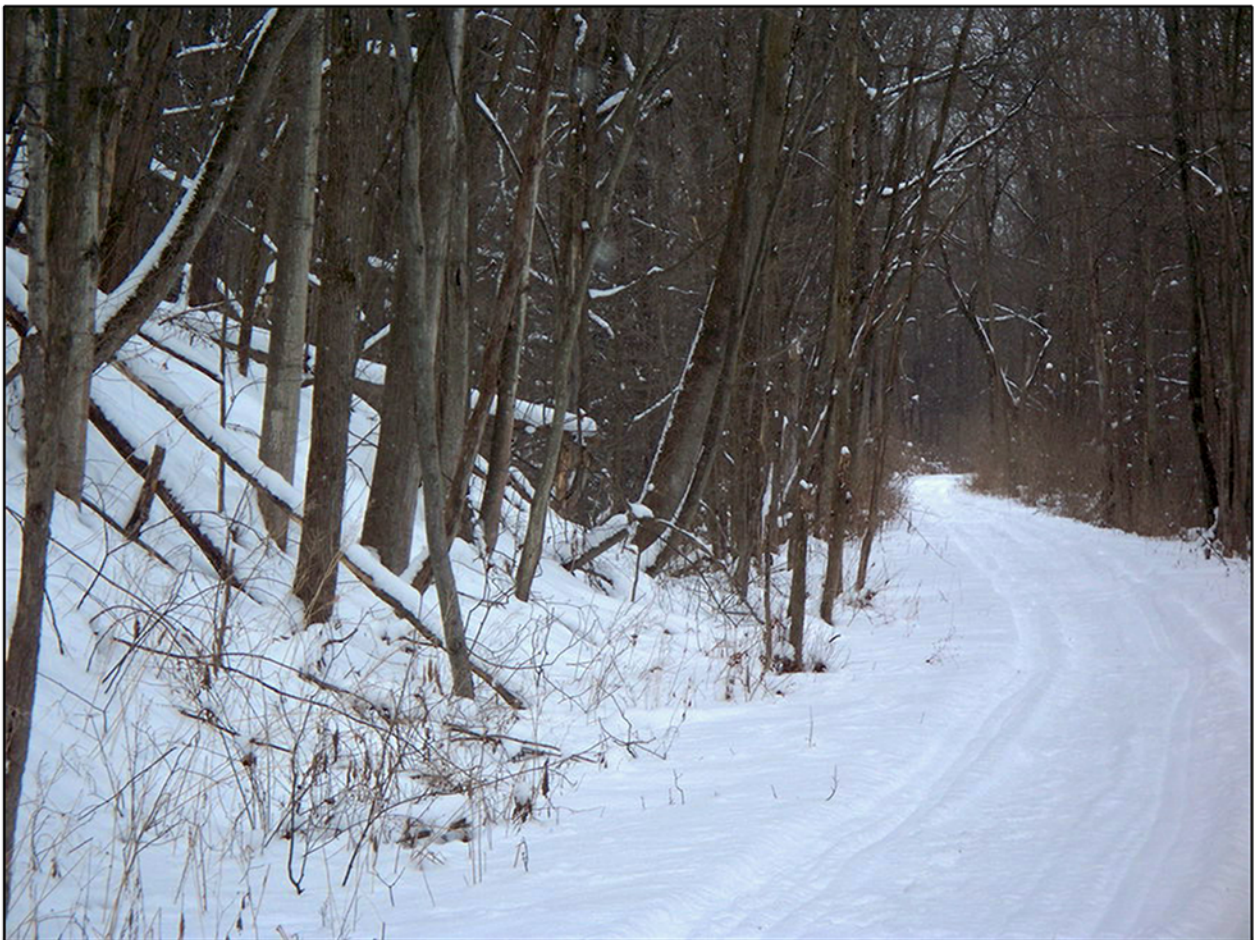
The same view as seen in January 2010 about 100 years later (Doug Ellison)

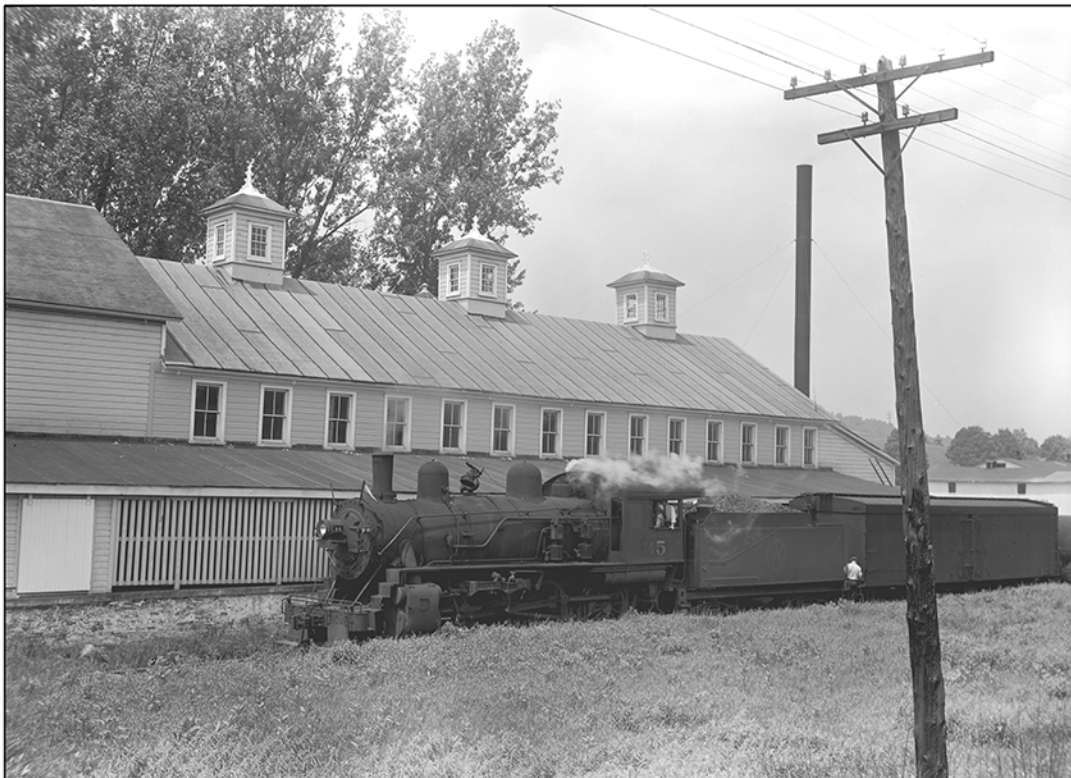
NYO&W 35 switches out Consumer's Dairy, "in the hole" at Earlville, NY. This was a 1946 excursion and was likely part of regular Milk Train 10. Doug Ellison Collection
