O&W Ramblings
Number 60 in a Series
Steam era “Pushers” and “Pushing”

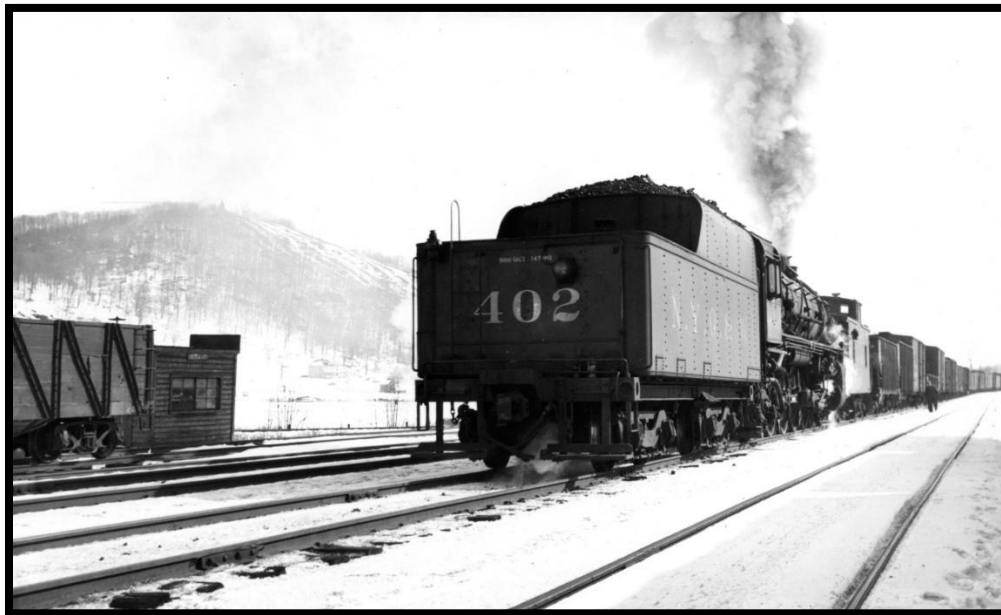
No. 402 pushing at VM headed towards Youngs Gap; – the Booster is not yet cut in witness an absence of exhaust steam boiling out over the top rear of the tender cistern. None of the other Class Y "Light 400" types were ever Booster equipped, and after a modest service the No. 402 had its Booster disassembled, removed and retired. The O&W never seemed to value the use of this accessory or its maintenance expense; -- quickly moving on from this experiment! Notice here that the pusher has coupled up directly behind the 8300 Series caboose; -- contrary to the prevailing legend that the 8300's had only a wooden frame not able to withstand the "push" without collapsing(!)

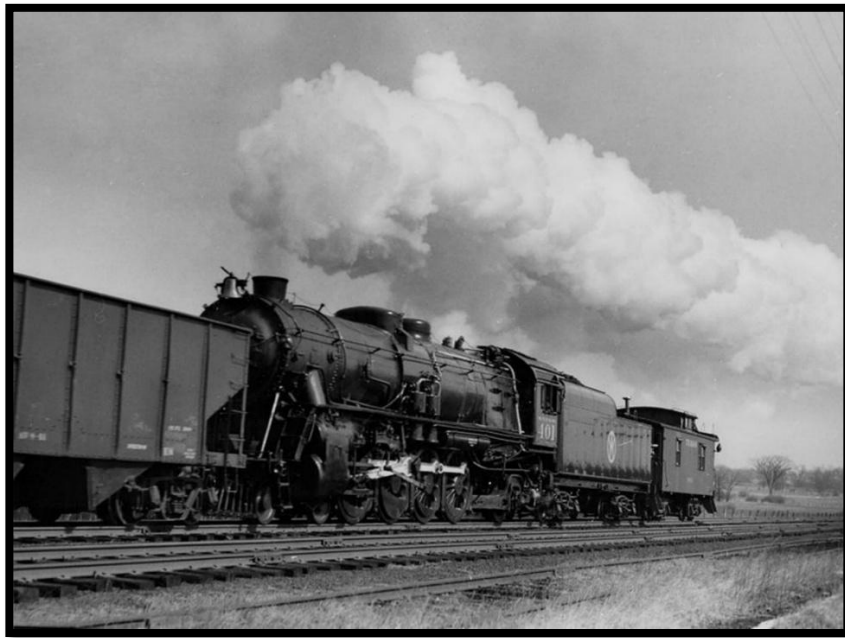
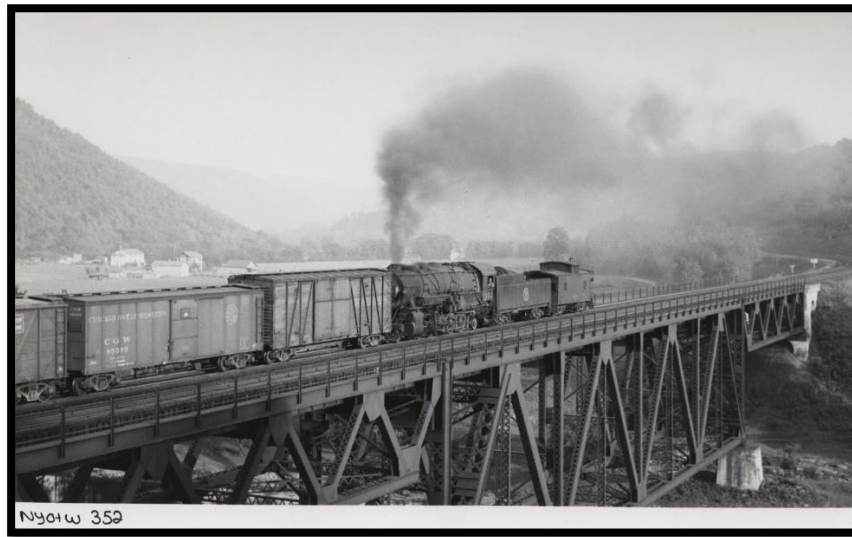
Both images here have the pusher with the 8300 Caboose trailing, TOP; - a Class Y "Light 400" 4-8-2 heaving on the end of a consist of steel hopper cars departing Summitville, with the locomotive looking quite smart and clean perhaps only recently shopped. Pusher assignments dispatched from conveniently located Summitville (at M.P. 93.11 only less than 15 Miles from the AV Shops – Wisner Ave. at M.P. 77.2) were common practice allowing a "break-in" following a trip for running gear servicing at the AV shops. BOTTOM: - A Class X 2-10-2 "Bullmoose" pushing a merchandise freight over the Delaware River bridge towards Cadosia and the junction with the O&W Southern Division mainline. The identity of this train is not annotated on my print, but it could very well be the "bottom" leg of SU-2 which was customarily handled by Bullmoose or Class P 2-8-0 Double Cab on the point and Bullmoose pushing to Cadosia where the workingman 2-8-0 Class W "Long Johns" handled the train(s) to Utica and points between.

So, which is it? The pusher behind the caboose, or the caboose switched and tacked on behind the pusher engine? A well and long held O&W myth is that the 8300 Series cabooses, with only wood underframes were not robust enough to withstand a pusher locomotive pushing directly on the caboose. . . . NOT TRUE! While that may have been the case with the earlier cabooses, or before systematic rebuilding(s); -- the 8300 Series caboose diagrams following specify steel underframes. It is well known that cabooses 8301, 8304 and 8308 were rebuilt with cut, sectioned and spliced back together cast steel tender frames from retired tenders, but that was more than likely at a later time in the 1930's when trains were longer and heavier to an extent that two pusher engines together were needed.

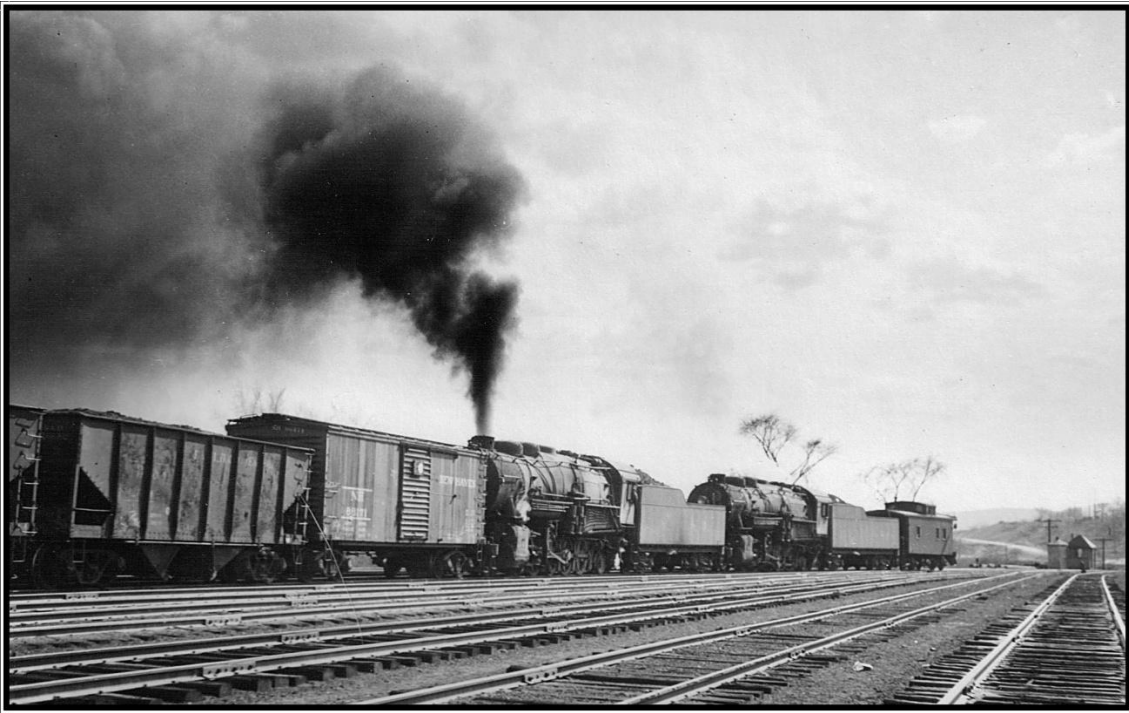
But not even robustly rebuilt welded cast steel caboose frames were deemed sufficient to withstand the multiple pusher Class X engine dispatch that is about to take place when this historic image was captured, so the caboose trails the pushers!

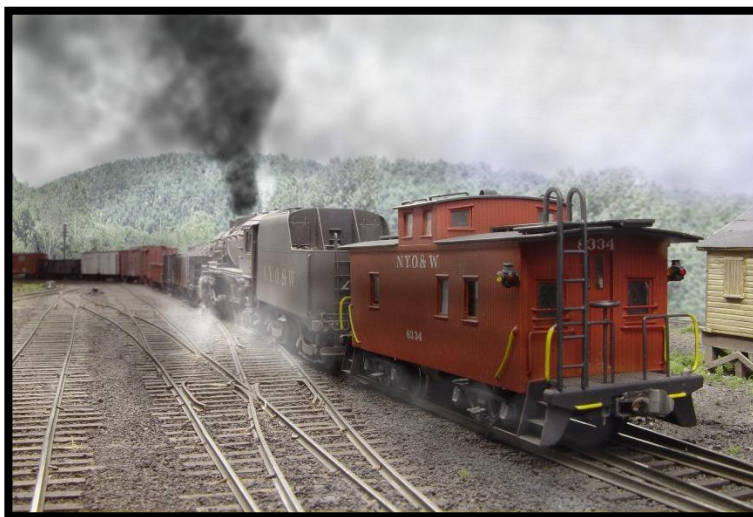
Here, posed on a Bill Schneider layout for a March 2004 RMC HO Scale "Fantrip" article, "Booster" equipped Class Y-1 4-8-2 is cut in ahead of Caboose No. 8304 to move a train out of Livingston Manor . . . unknown to the author / model photpgraphers that the pusher could have been simply bumped up to the caboose!
